[VAF Forums](#) > [Main](#) > [RV Building Tips/Techniques](#)
The Unhappy Crackly Club

**Scott Chastain****The Unhappy Crackly Club**

Note: This thread was originally posted in 2018. The third-party media host suddenly caused all the photographs to disappear and the thread was deleted. I have since repaired it and hope that others might benefit from a re-post.

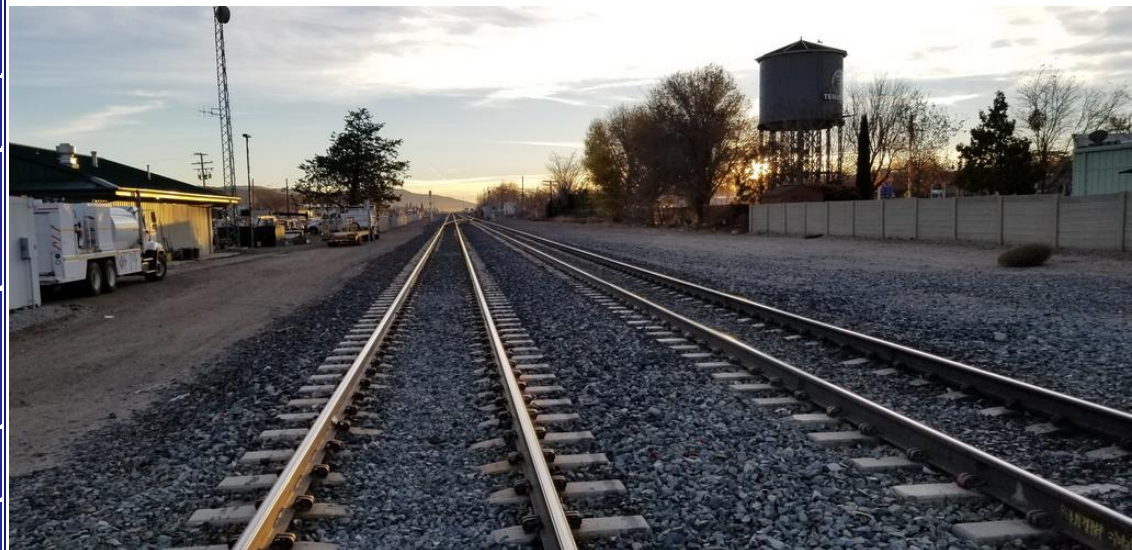
I awoke at first light. When I did, I quickly packed up my belongings and went out to the Dove to load up my sleeping gear. Pulling off the canopy cover, I discovered a ten-inch crack on the left side of the canopy directly over the passenger seat. Somewhat sickened by the sight, I covered it back up and spent the rest of the day exploring Tehachapi and mulling over my options with a pit in my stomach.

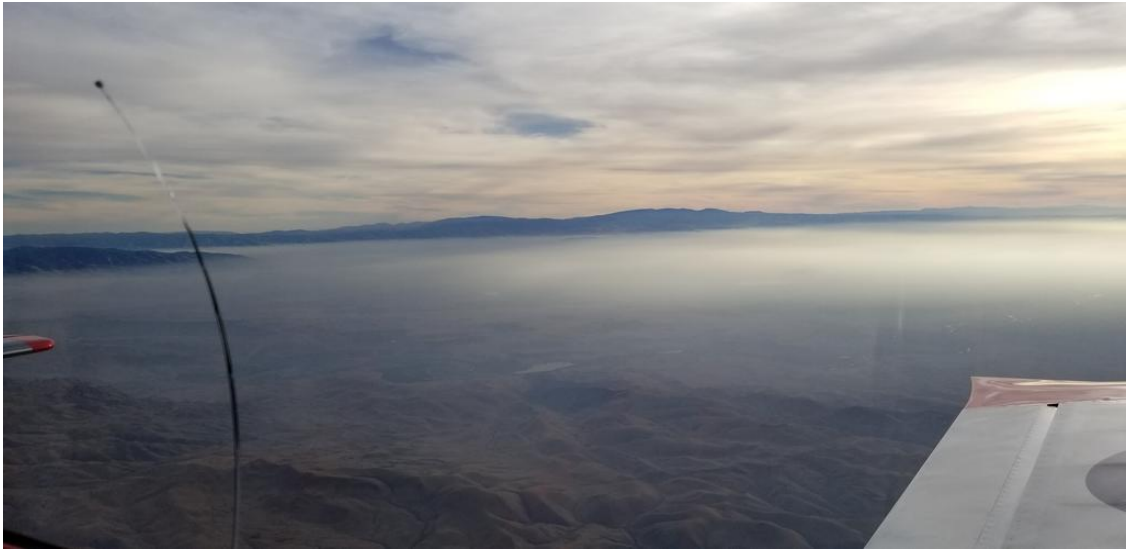
But over time, it did. I applied Weld-On #3 acrylic adhesive as some VAF members suggested. Then, two days before Christmas, I took a friend of mine to Half Moon Bay (HAF) for lunch. Following the return flight, I saw that the crack had splintered upward another 4 inches. I pulled the canopy and loaded it onto my truck to attempt a repair at home.

Later that afternoon, I found a local pilot by the name of Joe who helped me stop-drill the crack. I flew home to Merced (MCE) and watched the crack carefully over my left shoulder. It did not appear to be migrating further from the hole.

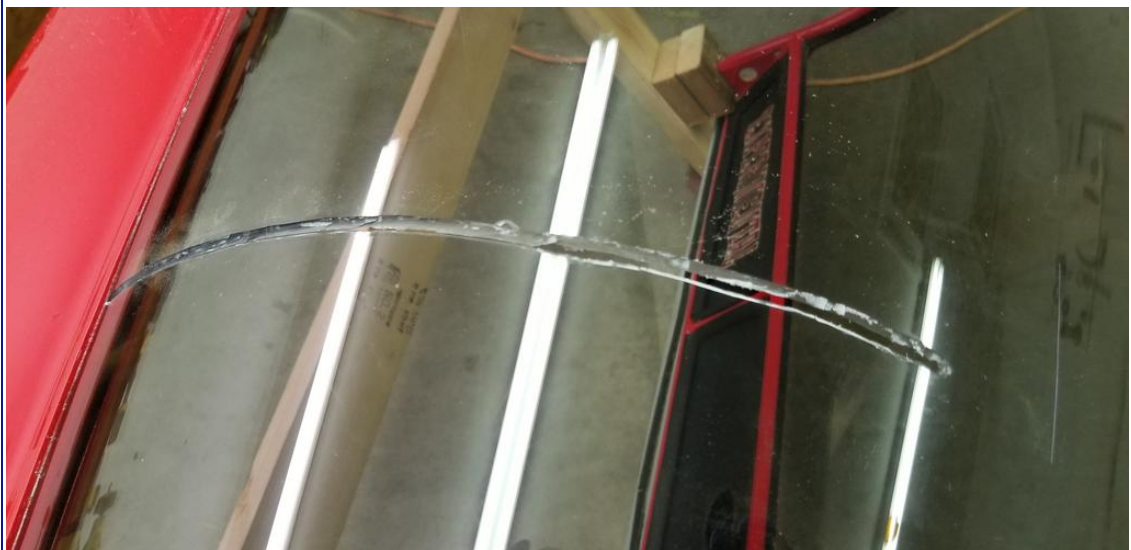
The crackline was clearly visible as the V-groove deepened.

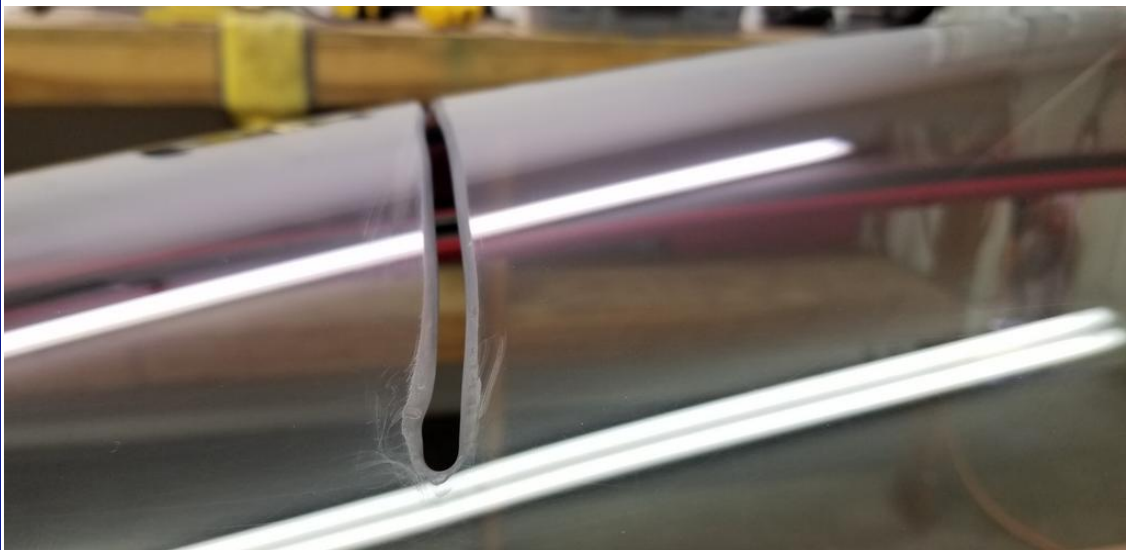
For the final 5 or 6 inches near the apex, the crackline suddenly began to flatten out and carry the fissure into the interior of the bubble at a 45-degree angle. For that reason, the V-groove was opened much wider at the top portion than at the base.

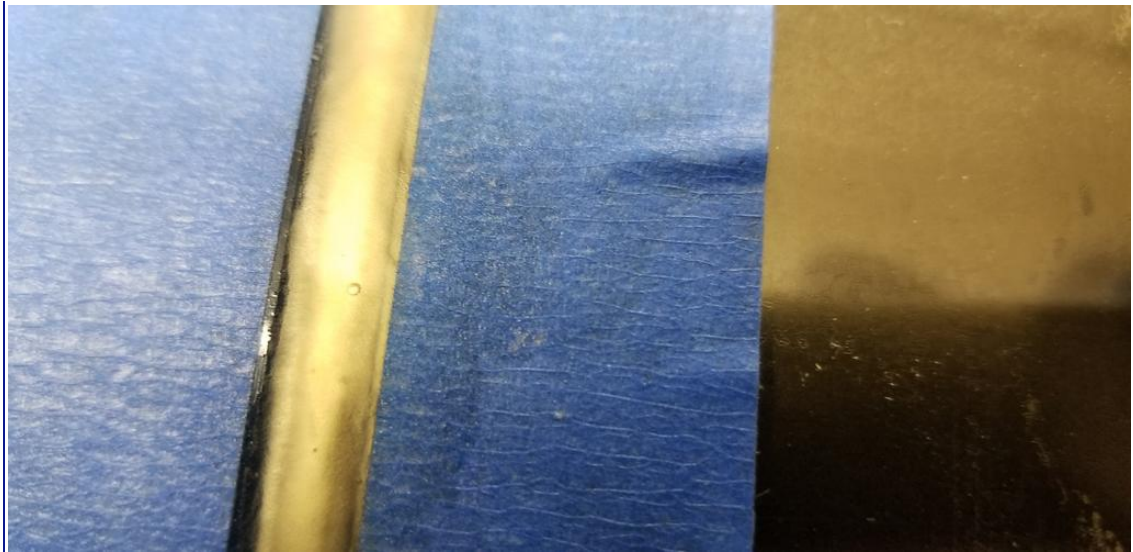
It was difficult to prevent a few bubbles from developing in the cured product. Fortunately, most bubbles rose to the surface before the mixture hardened and were popped with the syringe and filled on the subsequent layer. Others did not.

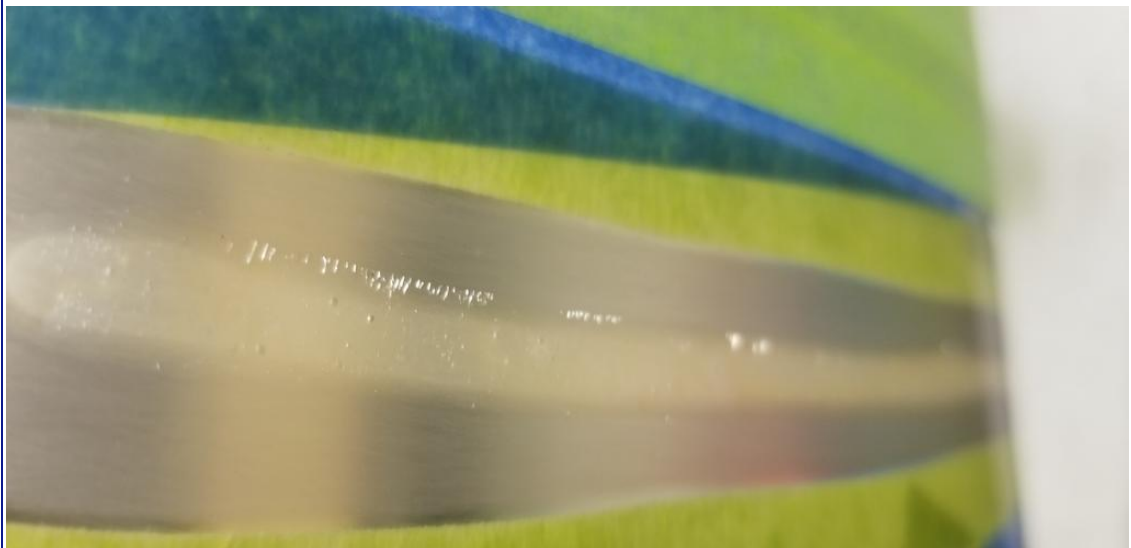
As the polishing progressed, small occlusions became visible along the upper edges of the V-groove.

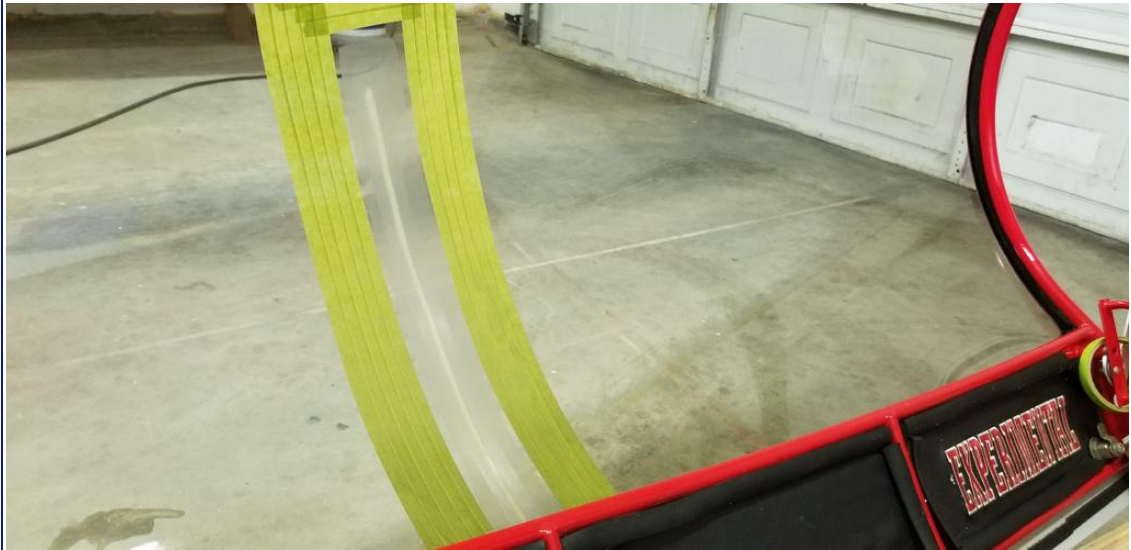
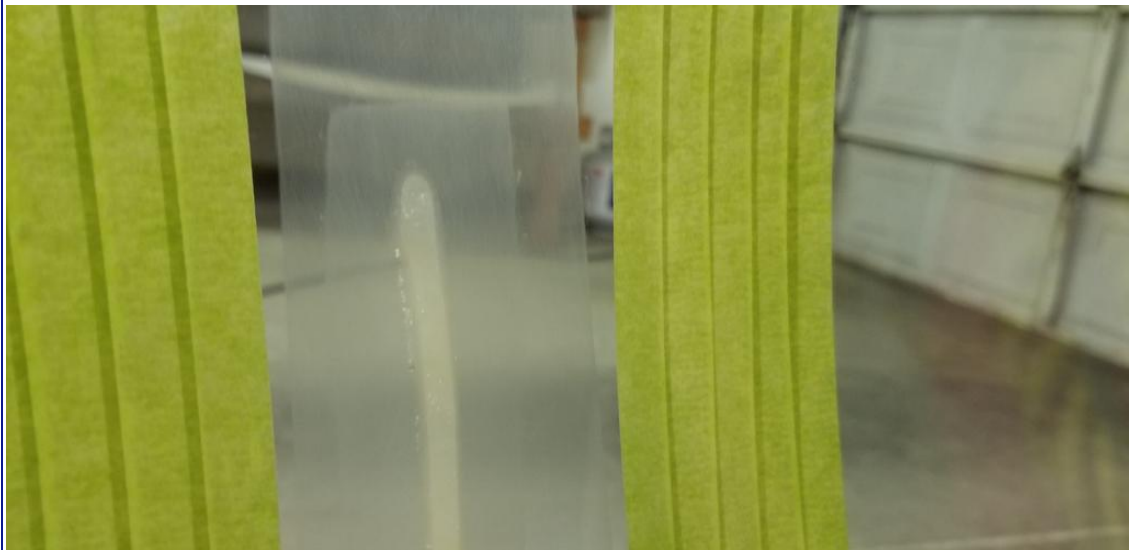
The cause of the occlusions was unknown. Great care was taken to clean the plastic prior to bonding. Nevertheless, whether or not the imperfections would develop into full-blown cracks was yet to be seen. The worst-case scenario would be a repeat of the repair process a second or even a third time, and if those attempts failed, a full canopy replacement would likely be in order. Thus, it was decided to allow the occlusions to remain for in-flight testing.

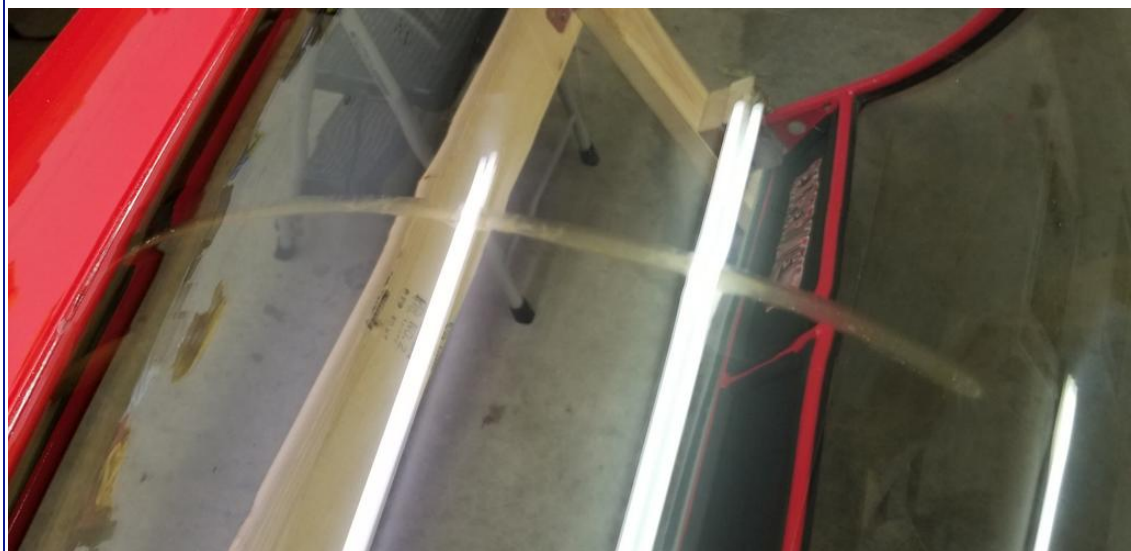
The final result was a canopy that appeared at first glance undamaged, although some distortion was noticeable when the original scar was examined closely. The removal of material during the polishing process made such distortion unavoidable. Additionally, the scar was opaque and not by any means as clear as the surrounding acrylic. Nevertheless, the canopy appeared structurally sound and worthy of flight.

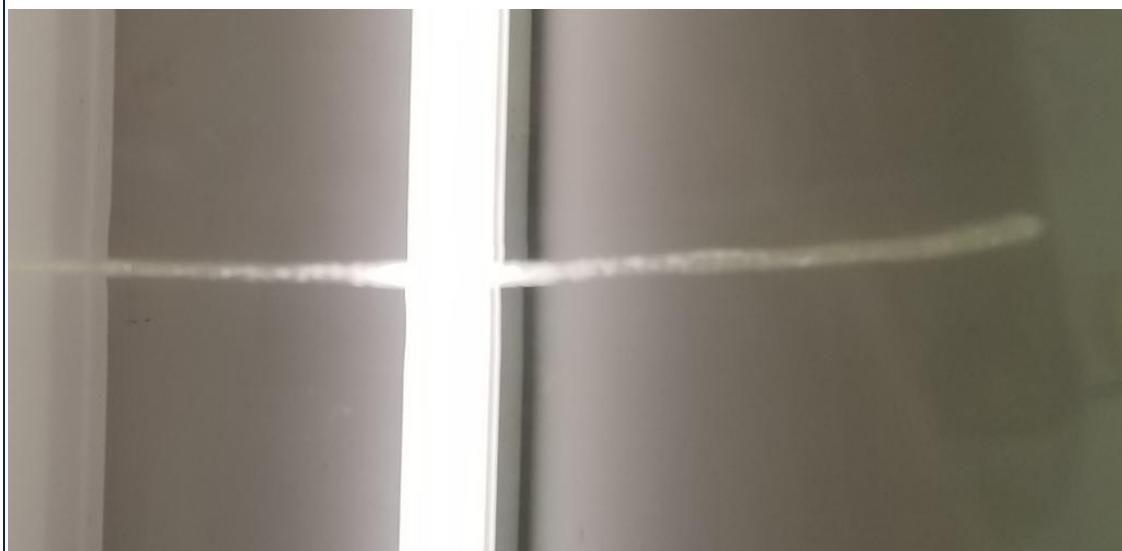
A view from the interior revealed a few areas where further application of polishing compound was needed.

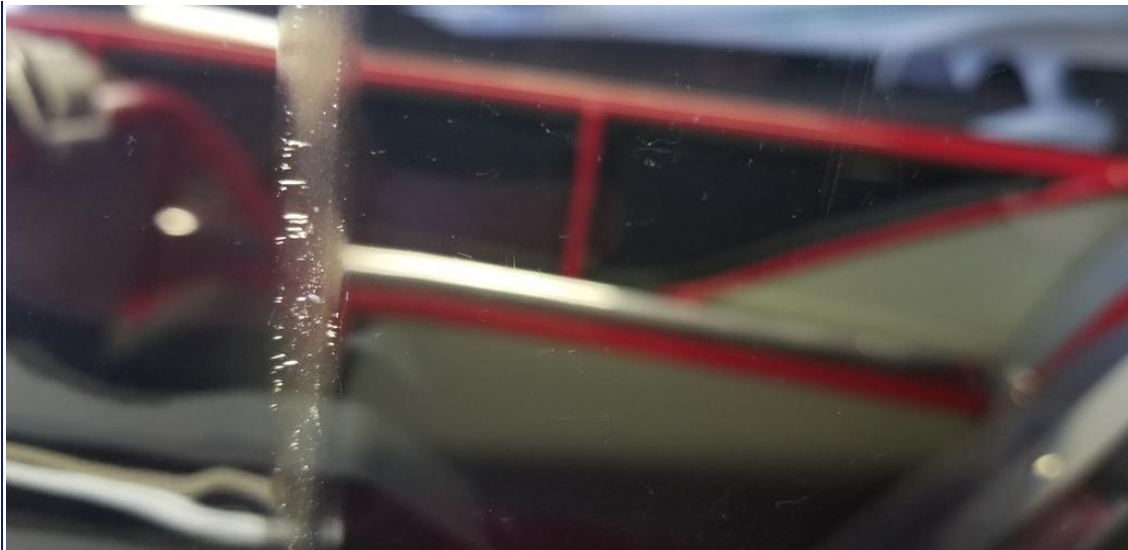
Back in the hangar, I took another close-up shot of the worrisome occlusions that became apparent during the polishing process. Compared to photos taken before startup, no changes were noted during the 1.03-hour flight.
