[VAF Forums](#) > [Main](#) > [RV Building Tips/Techniques](#)
The Unhappy Crackly Club

**Scott Chastain****The Unhappy Crackly Club**

Note: This thread was originally posted in 2018. The third-party media host suddenly caused all the photographs to disappear and the thread was deleted. I have since repaired it and hope that others might benefit from a re-post.

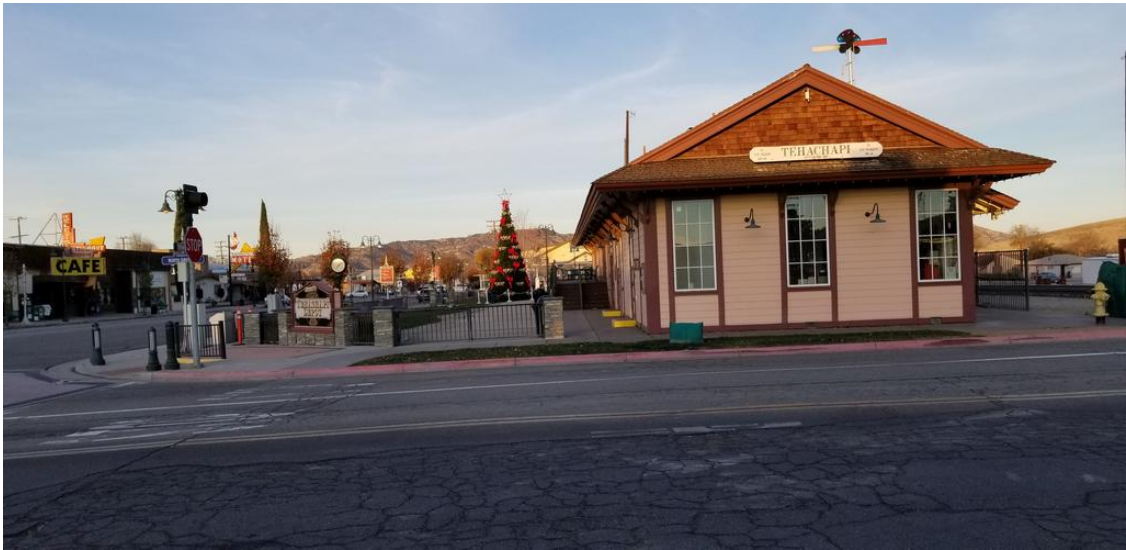
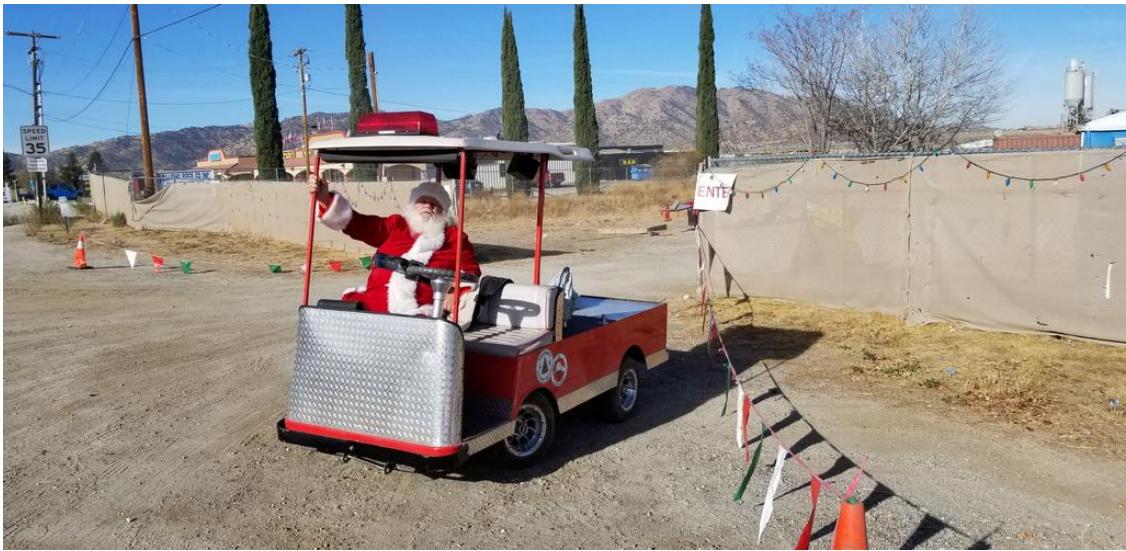
I awoke at first light. When I did, I quickly packed up my belongings and went out to the Dove to load up my sleeping gear. Pulling off the canopy cover, I discovered a ten-inch crack on the left side of the canopy directly over the passenger seat. Somewhat sickened by the sight, I covered it back up and spent the rest of the day exploring Tehachapi and mulling over my options with a pit in my stomach.

Later that afternoon, I found a local pilot by the name of Joe who helped me stop-drill the crack. I flew home to Merced (MCE) and watched the crack carefully over my left shoulder. It did not appear to be migrating further from the hole.

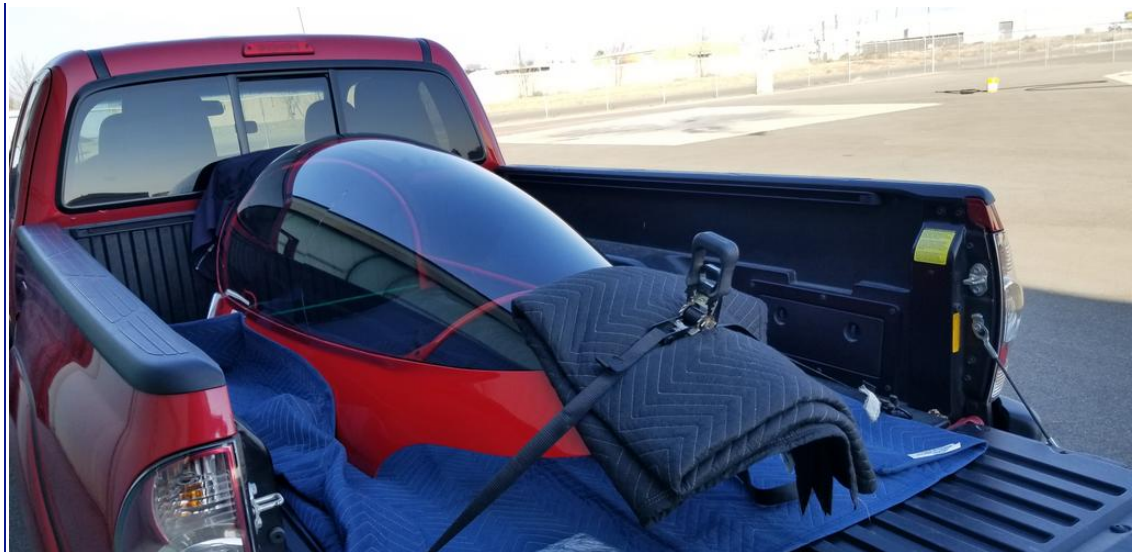
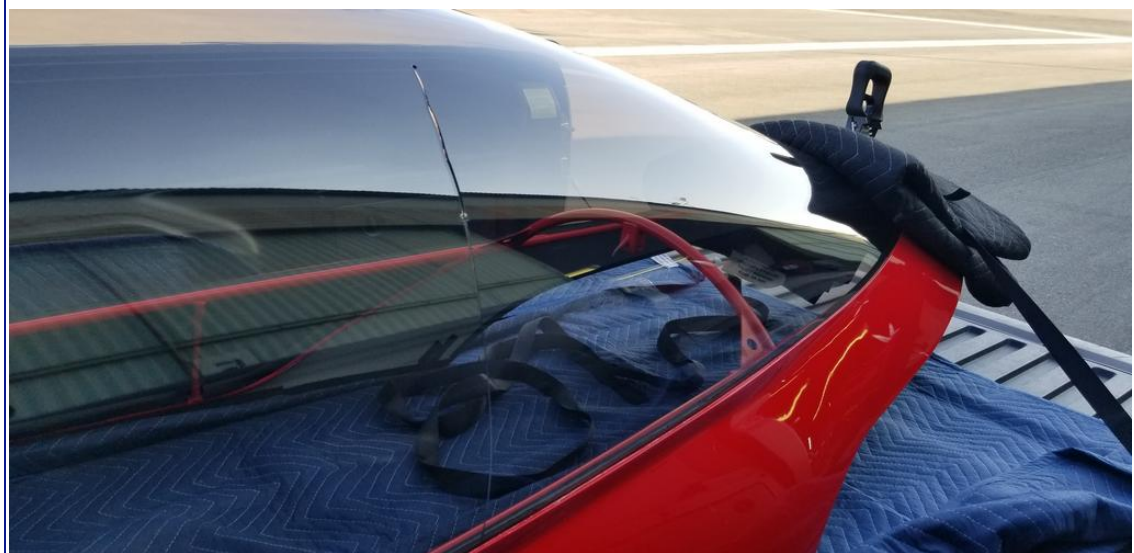
But over time, it did. I applied Weld-On #3 acrylic adhesive as some VAF members suggested. Then, two days before Christmas, I took a friend of mine to Half Moon Bay (HAF) for lunch. Following the return flight, I saw that the crack had splintered upward another 4 inches. I pulled the canopy and loaded it onto my truck to attempt a repair at home.

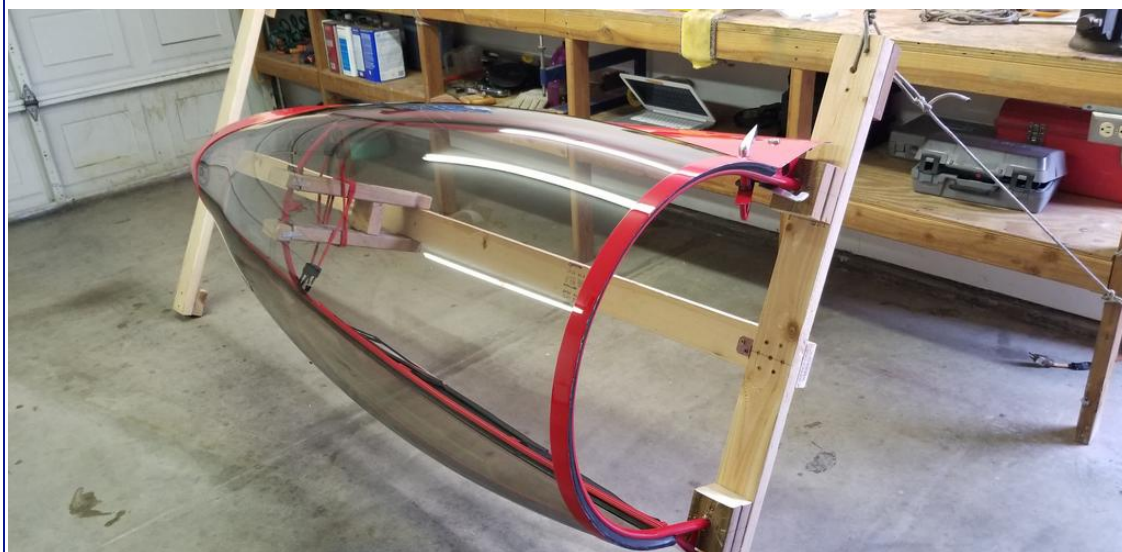
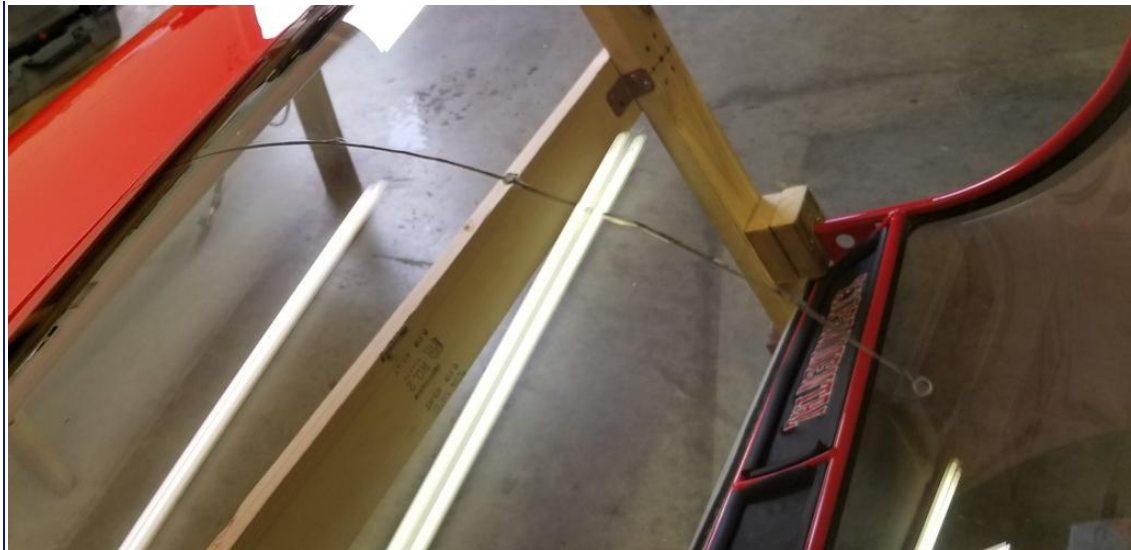
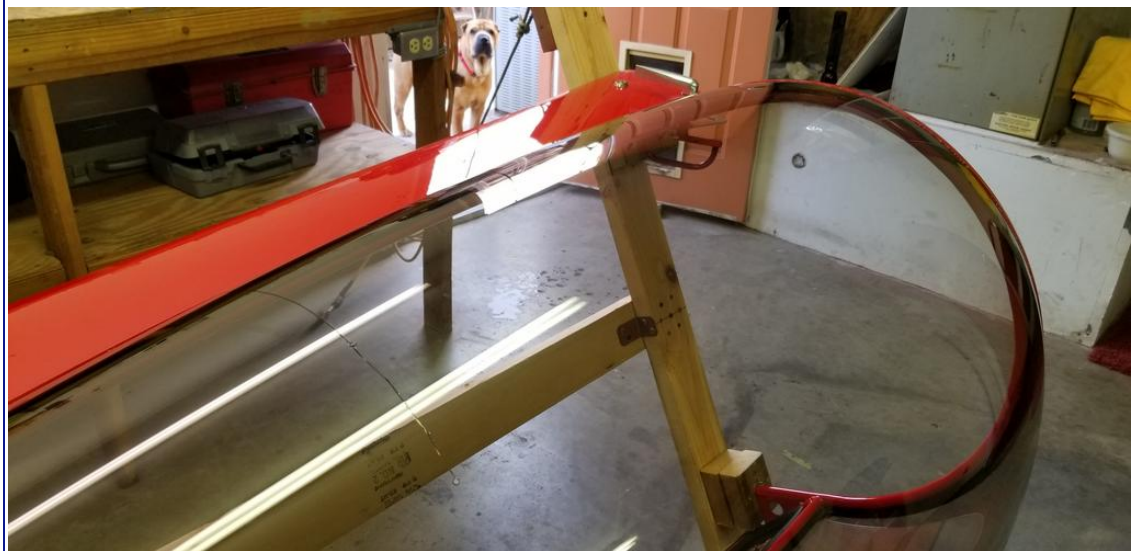
There were well over 1400 airframe hours on the canopy, and many thousands of hours beyond that were spent baking in the sun during airshow performances and flightline displays. About 100 Hobbs hours prior to becoming a part of the Unhappy Cracky Club, the canopy began sliding on the rail with difficulty. At first, I attributed the rough slide to a worn-out C-661 slider block; following the flightline fissure in Tehachapi, however, it was obvious that a side load on the block was causing the problem. The plexiglass had shrunk and pulled the frame to such an extent that the sliding process was being impeded. After the crack occurred, the canopy suddenly glided freely again on the rails.

The repair process began by heating the shop to over 70-degrees and positioning the canopy so that the crack lay horizontally. The surgical area was thoroughly washed with soap and water, then cleaned with PPG DX330 Acryli-Clean.

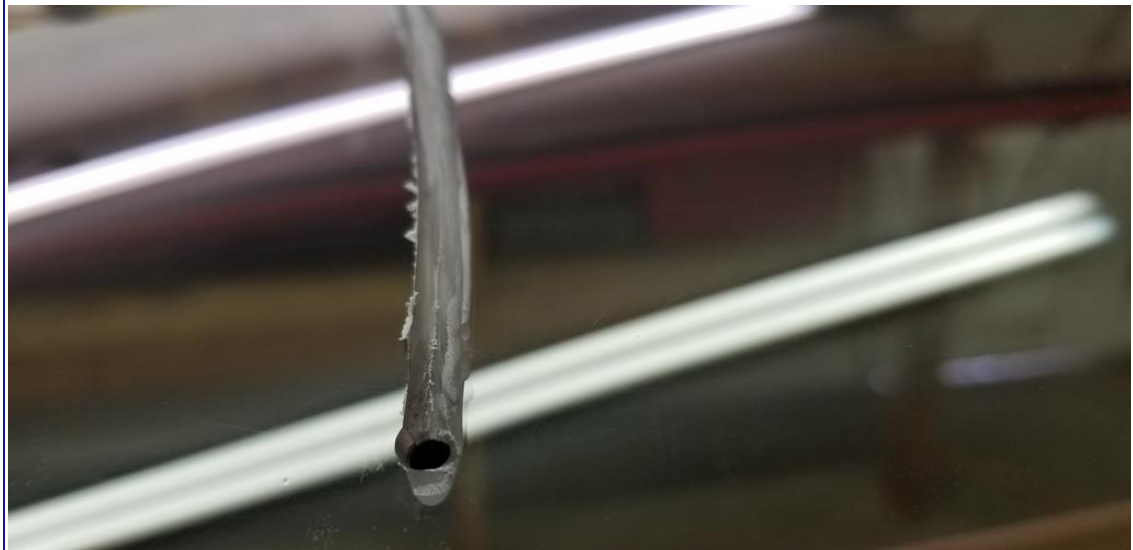
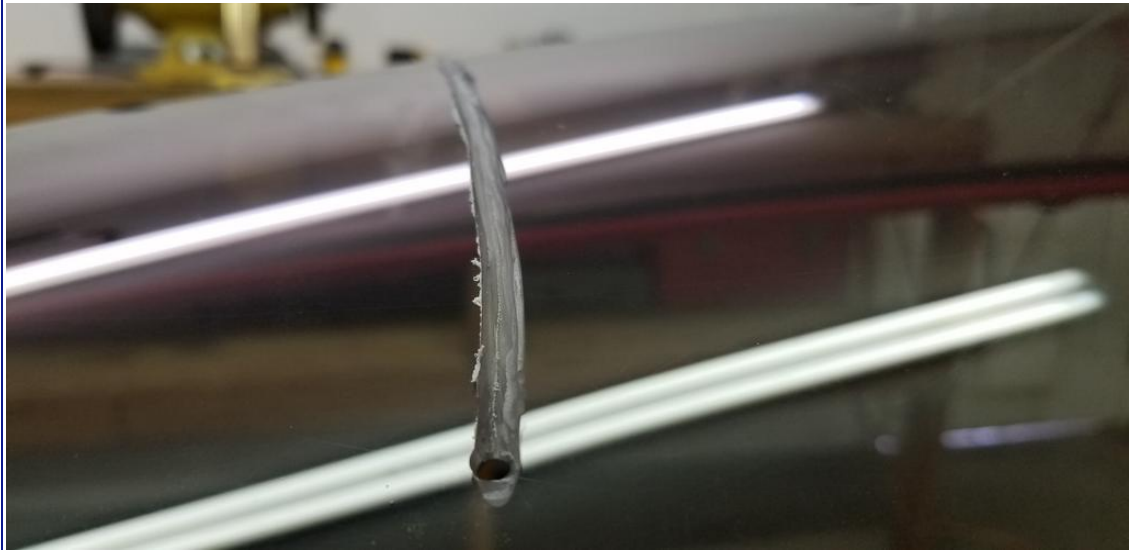
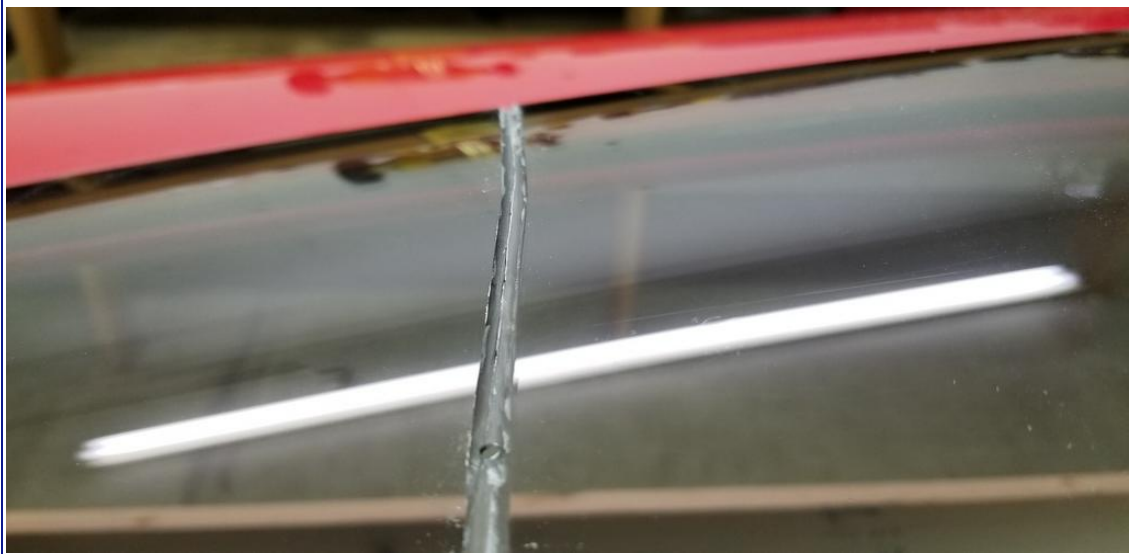
The crackline was clearly visible as the V-groove deepened.

The Dremel bit was patiently and gradually worked to follow the crack deeper and deeper into the plexiglass as the V-groove began to form.

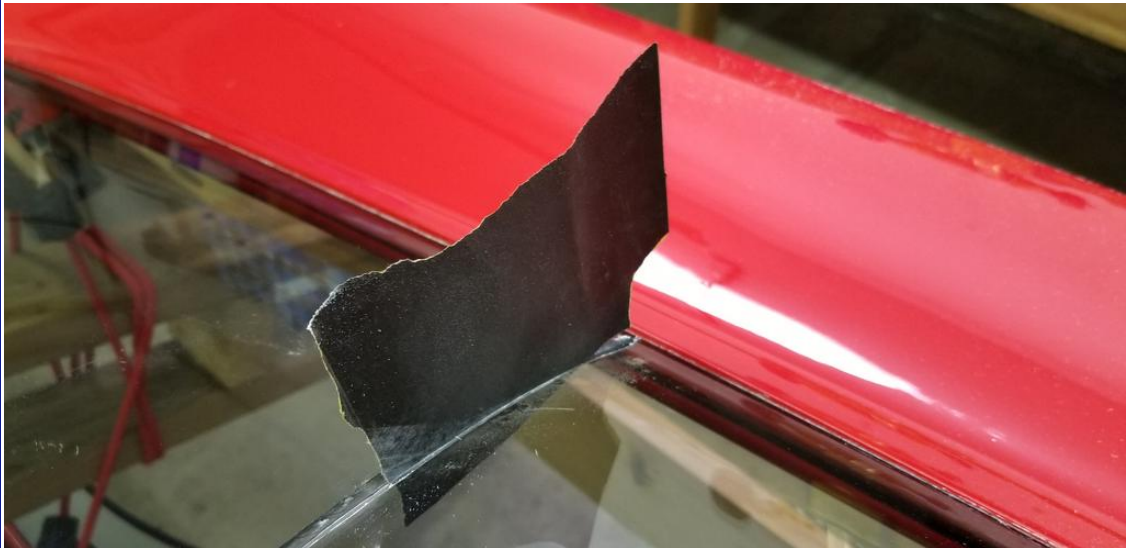
For the final 5 or 6 inches near the apex, the crackline suddenly began to flatten out and carry the fissure into the interior of the bubble at a 45-degree angle. For that reason, the V-groove was opened much wider at the top portion than at the base.

A piece of wet-dry sandpaper was inserted at the base of the crack as the V-groove channel widened.

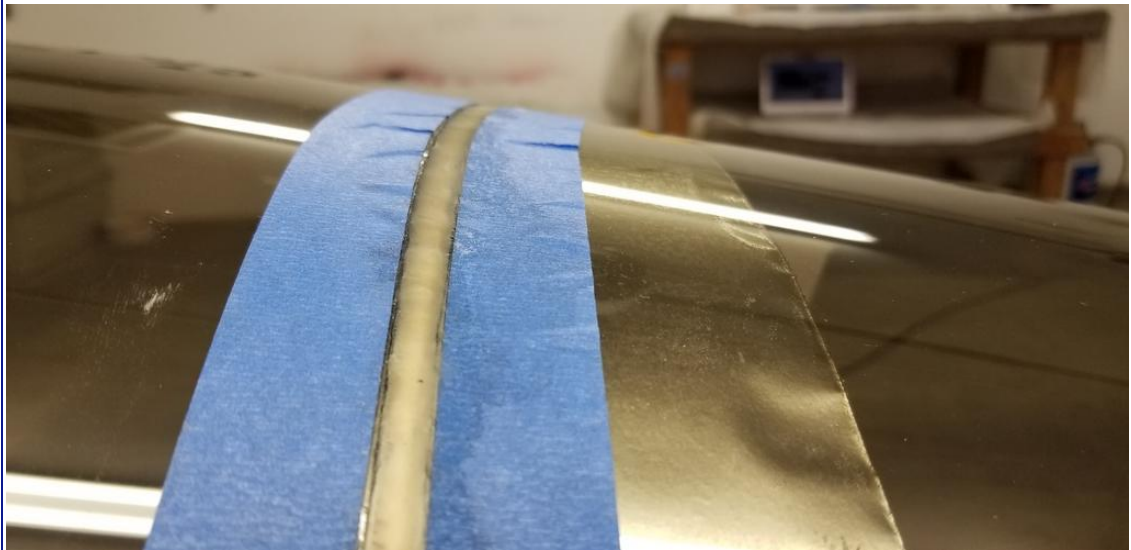
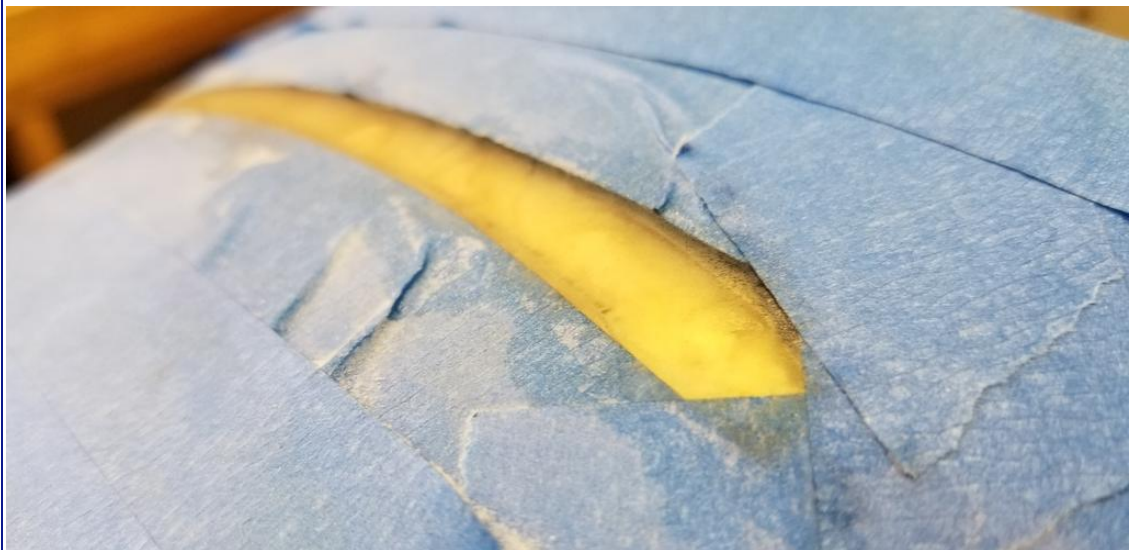
It was difficult to prevent a few bubbles from developing in the cured product. Fortunately, most bubbles rose to the surface before the mixture hardened and were popped with the syringe and filled on the subsequent layer. Others did not.

There was a short cure time of about ten minutes between layers. The process was repeated several times until the cured bonding agent uniformly filled the V-groove.

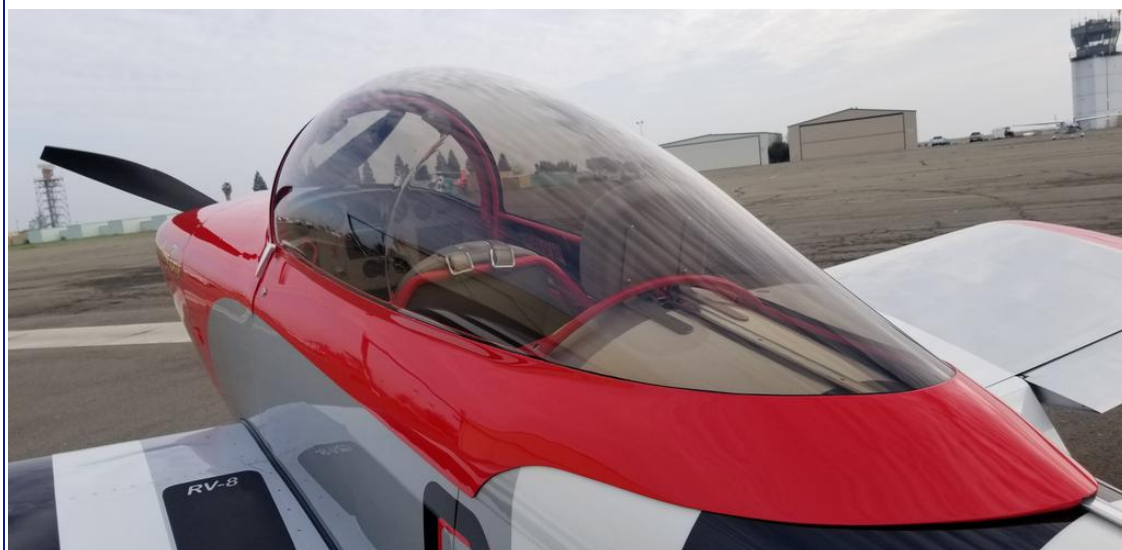
I noted the occlusions and took a few pictures of the repair. Then I strapped in, cranked over and taxied out. The first hour of flight testing would be simple but comprehensive.

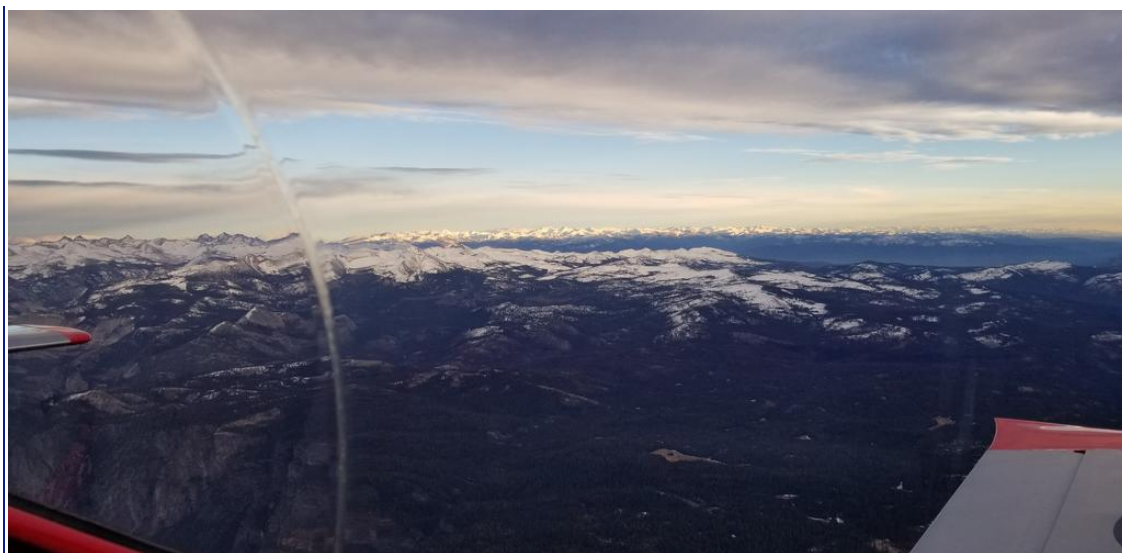
The acrylic bond appeared to be unaffected by the cold, and in the occlusions no apparent changes were seen.
